COLECO ADAM C88

7-PIN DIN AUDIO BALANCE FIX

TECHNICAL
SERVICE BULLETIN

JL-DELTA-01
REVISION A
4/21/2021

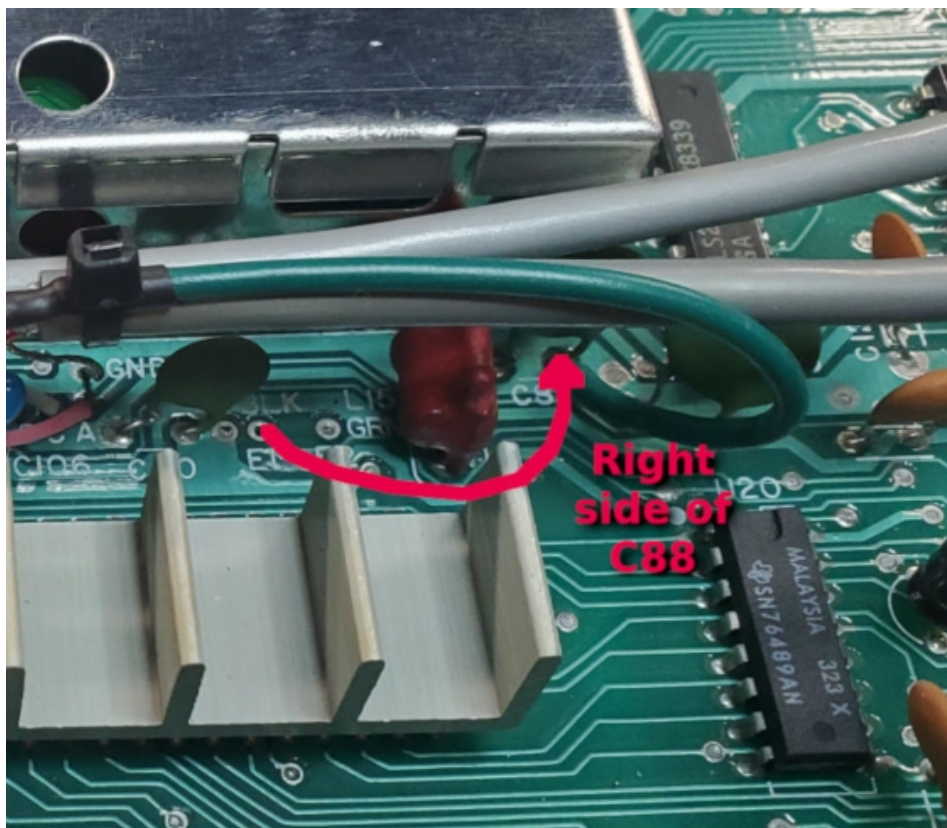
A design flaw has the audio connection source to the 7-Pin DIN incorrectly placed. The standard E1 connection by Coleco is connected to the wrong side of R18 (1.8K). This incorrect position has the ADAM and I/O expansion audio sources on opposite ends of the resistor and therefore causing the unbalanced audio. This flaw is especially noticeable while using the Super Game Module (SGM).

To correct this issue, the audio source E1 needs to be moved. Since R18 is under the RF Module, the same connection can also be made by moving the E1 wire to the right side of the easier to reach C88.
